Long term UV tests on Ultracur3D® RG 1100

This document is intended to provide guidance for manufacturers regarding ageing of the 3D printed materials under Ultraviolet radiation or UV. BASF3D Printing Solutions GmbH has performed specific ageing tests for the material Ultracur3D® RG 1100. Indications on material changes that can occur during the ageing process were studied. It remains the responsibility of the device manufacturers and/or end-users to determine the suitability of all printed parts for their respective application.

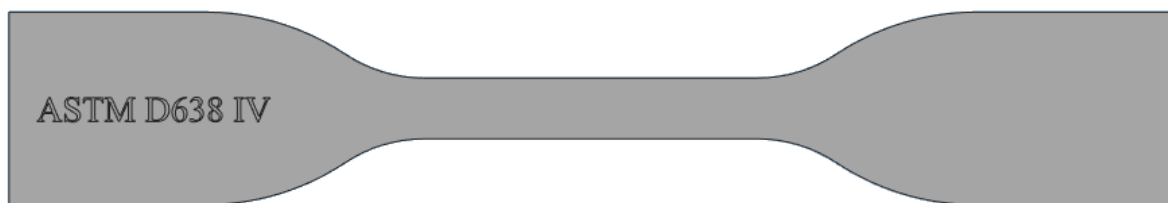
Figure 1 Tensile bar

25 tensile bars and 15 color cones were printed with the material and were kept under high intensity UV light for longer period. The parts were also exposed to periodic water sprays as described above. After the tensile bars were inside the UV oven for a stipulated time, the change in color as well as the mechanical properties like E modulus, Tensile strength and Elongation at break were measured. The tensile bars were used for mechanical testing and color cones were used to determine the color after Prolonged UV exposure.

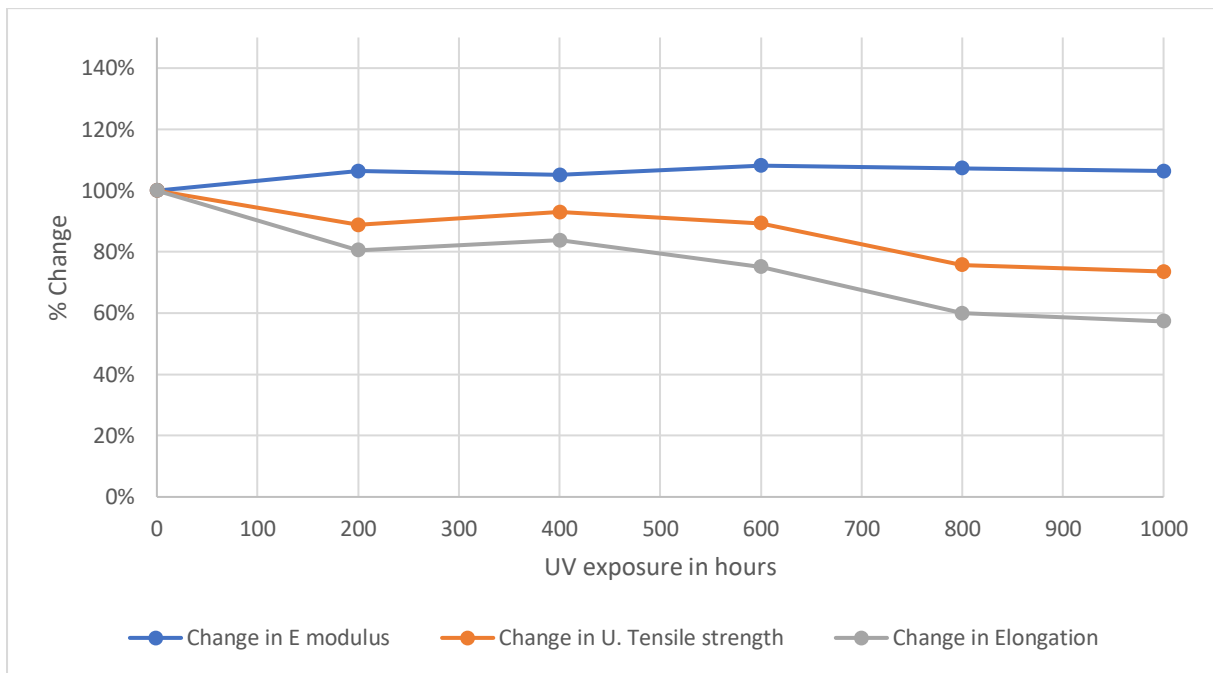
Figure 3 Change in mechanical properties over the course of 1000 hours of UV exposure

When looking at the mechanical properties of the material, the elastic modulus remains stable, ultimate tensile strength and elongation at break reduce slowly after long exposure times.

After around 1000 hours of long-term UV exposure, the final values can be seen in the table below:

Table 2 Mechanical properties before and after 1000 hours of UV exposure as per ISO 4892:2 method A

| Property | Before Long term UV exposure | After 1000 hours of UV exposure |
| Elastic modulus | 2930 MPa | 3115 MPa |
| Ultimate tensile strength | 80 MPa | 59 MPa |
| Elongation at break | 4 % | 2 % |
